BUREAU OF SHIPS GROUP
TECHNICAL INSPECTION REPORT

⑥ OPERATION CROSSROADS.
U.S.S HUGHES (DD410).
TEST BAKER.

VOLUME II [u] ⑧

USS HUGHES (DD410)

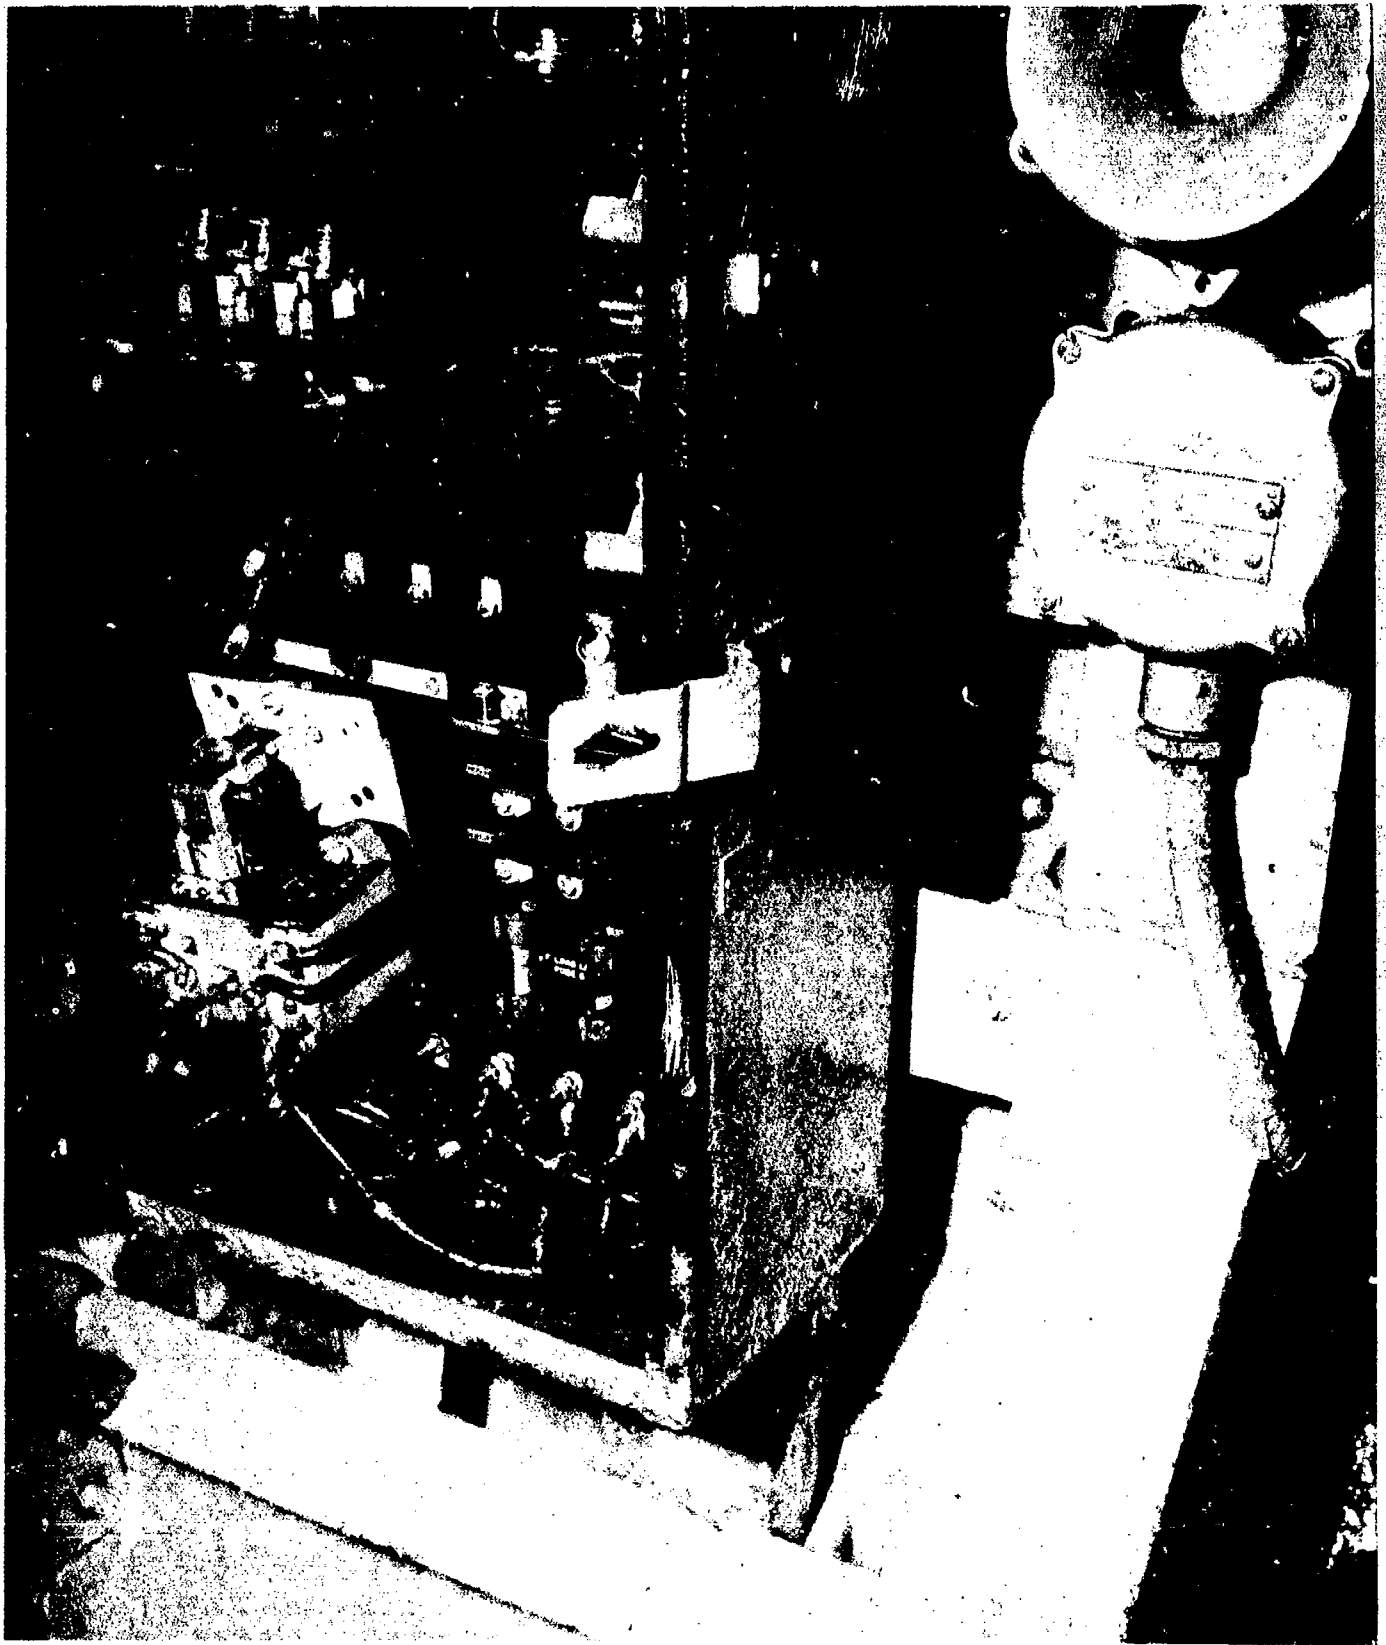
AB-CR-68-2950-3. Diesel fuel oil supply pump motor mounted in the after engine room. Shows contactor broken away from the phenolic base. Picture taken looking to starboard.
